12 Solutions for Fixing Common TEV Problems

The purpose of this form is to cover the higher percentage problems and repair procedures of TEVs in supermarket applications.

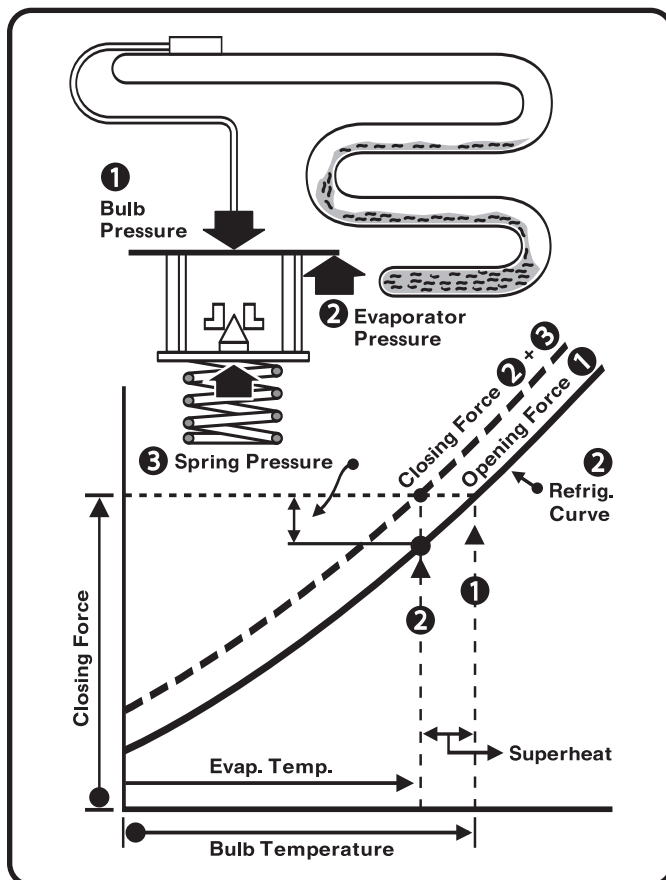
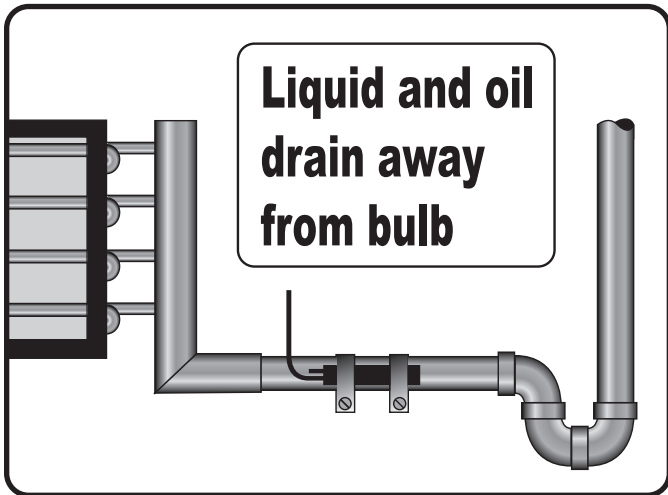
#2 — Check the Sensing Bulb Location: The sensing bulb should be securely fastened to a clean, straight section of the suction line. The bulb should not be influenced by ambient air temperature. The bulb should be attached to a horizontal suction line at the evaporator outlet. If the bulb cannot be located in this manner it may be located on a descending vertical line only. On suction lines 7/8" and larger, it should be installed at 4 or 8 o'clock on the

The sensing bulb should be securely fastened to a clean, horizontal section of the suction line at the evaporator outlet.

Verify the sensing bulb is correctly installed.

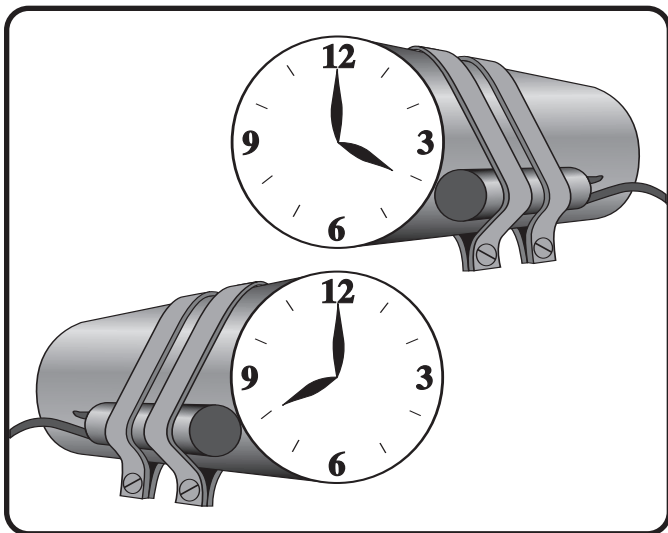
On suction lines 7/8" and larger, the sensing bulb should be installed at 4 or 8 o'clock on the side of the horizontal line.

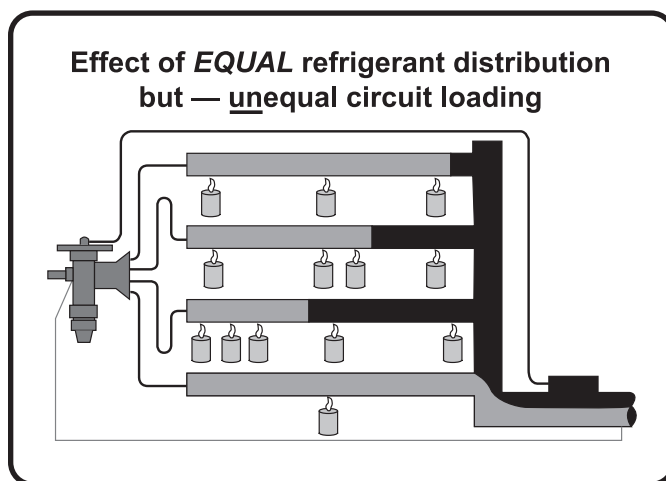
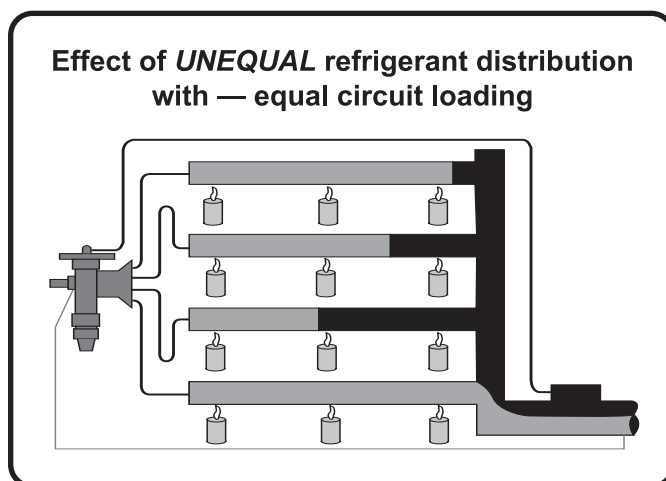
These illustrations depict conditions that result in a loss of heat transfer due to either (top) unequal circuit loading or (bottom) unequal refrigerant distribution.

Loading: Multi-circuit evaporators and parallel evaporators connected to a single refrigerant distributor must receive an equal percentage of the total load. When each circuit is not subjected to the same heat load, the lightly loaded circuits will allow liquid refrigerant or low temperature vapor to

enter the suction line and throttle the TEV. This will cause normally loaded circuits to be deprived of their share of the refrigerant. The net result is a loss of refrigerated evaporator surface and a potentially oversized TEV. Check the temperature of the suction outlets of each distributor circuit before the suction header. Unequal temperatures at these locations are the result of unequal loading.

Check with the equipment manufacturer for the correct distributor and nozzle assembly if poor distribution is diagnosed.
